CITY OF UTICA RESERVOIR 2
ONEIDA COUNTY,
NEW YORK

INVENTORY NO NY 197

PHASE I INSPECTION REPORT,

(6) NATIONAL DAM SAFETY PROGRAM.

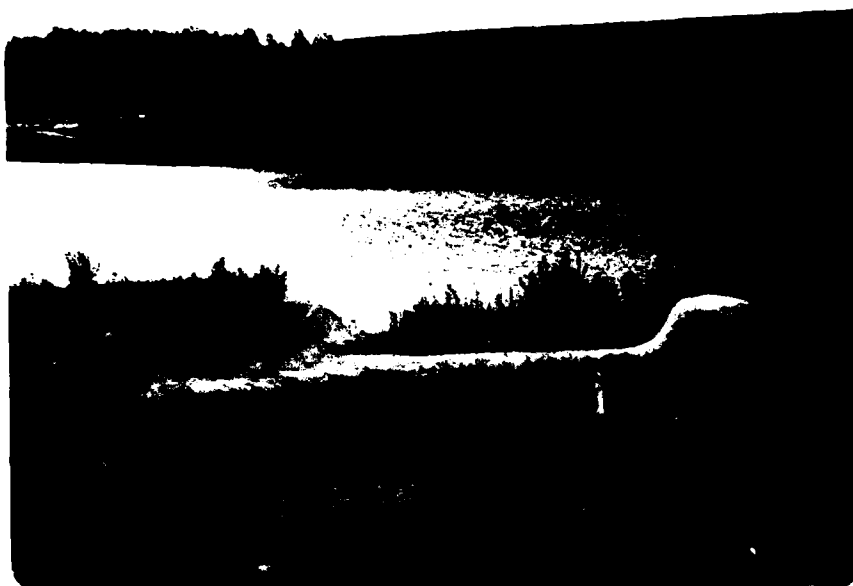
1. View of Reservoir No. 2 looking north
